A REPORT ADVOCATING FOR SOCIALLY
RESPONSIBLE SUSTAINABLE DEVELOPMENT

EXAMINATION OF THE USE OF POLYCARBONATE IN COMMERCIAL SKYLIGHTS

RESEARCH BY ENEREF INSTITUTE SHOWS THAT BETTER-
PERFORMING POLYCARBONATE FOR SKYLIGHTS IS WORTH
STRIVING FOR DESPITE INDUSTRY MISPERCEPTIONS.

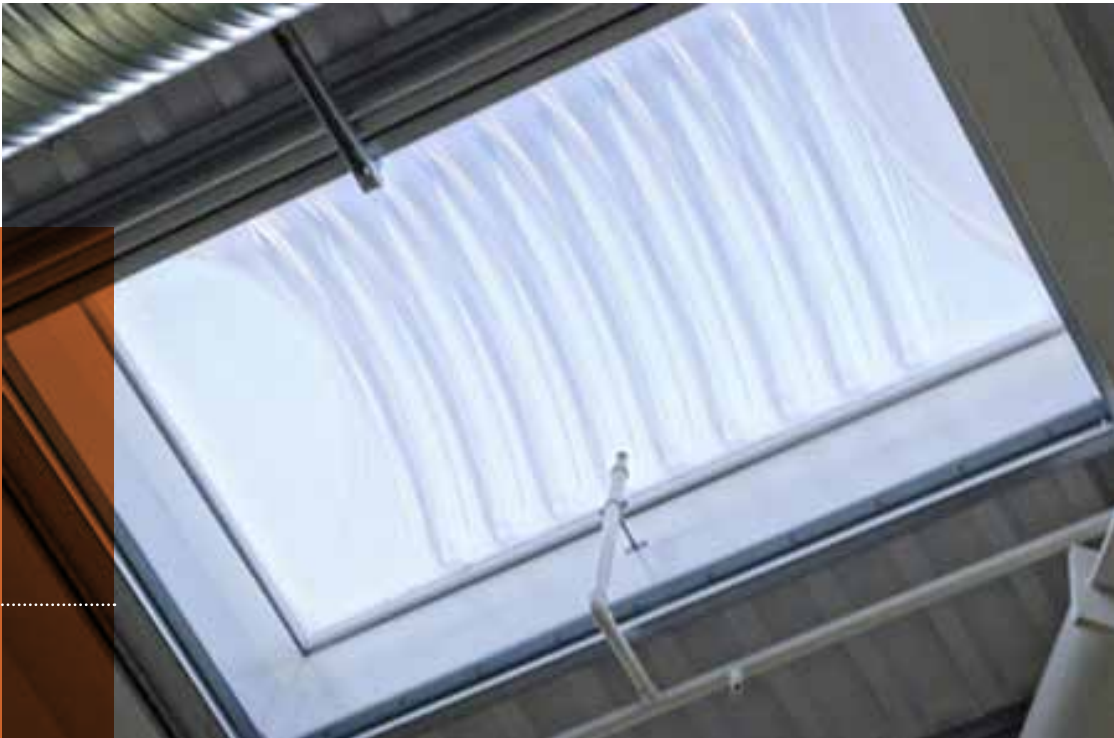
POLYCARBONATE SKYLIGHT

High-performance prismatic skylights are ideal for commercial applications
